Repair System for Protection Against Abrasive Attack

BELZONA
1814

Belzona 1814 is a cost-effective three-component repair system for the protection of surfaces subject to abrasive attack.

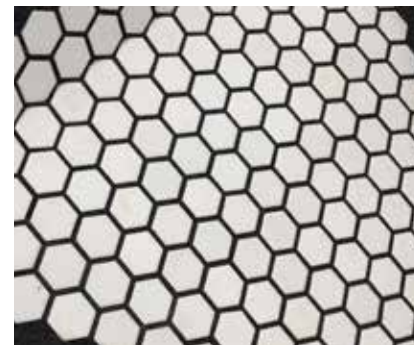
Grouting for alumina tiles

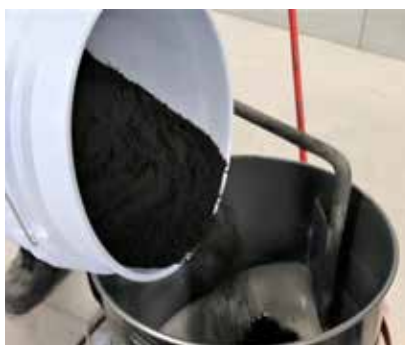
Simple mixing

Supplied as a three-part system, with a base, solidifier and aggregate, Belzona 1814 is easy to mix and apply without the need for specialist tools.

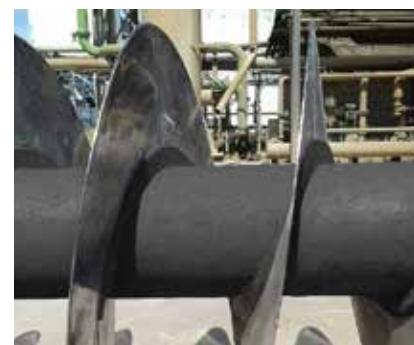
Easy application

The material is easy to mix and benefits from extended working life making it ideal for large areas. During application, no specialist tools are necessary and it is possible to apply thick and thin sections in one operation.
